## Highlands College Estate - October 2024

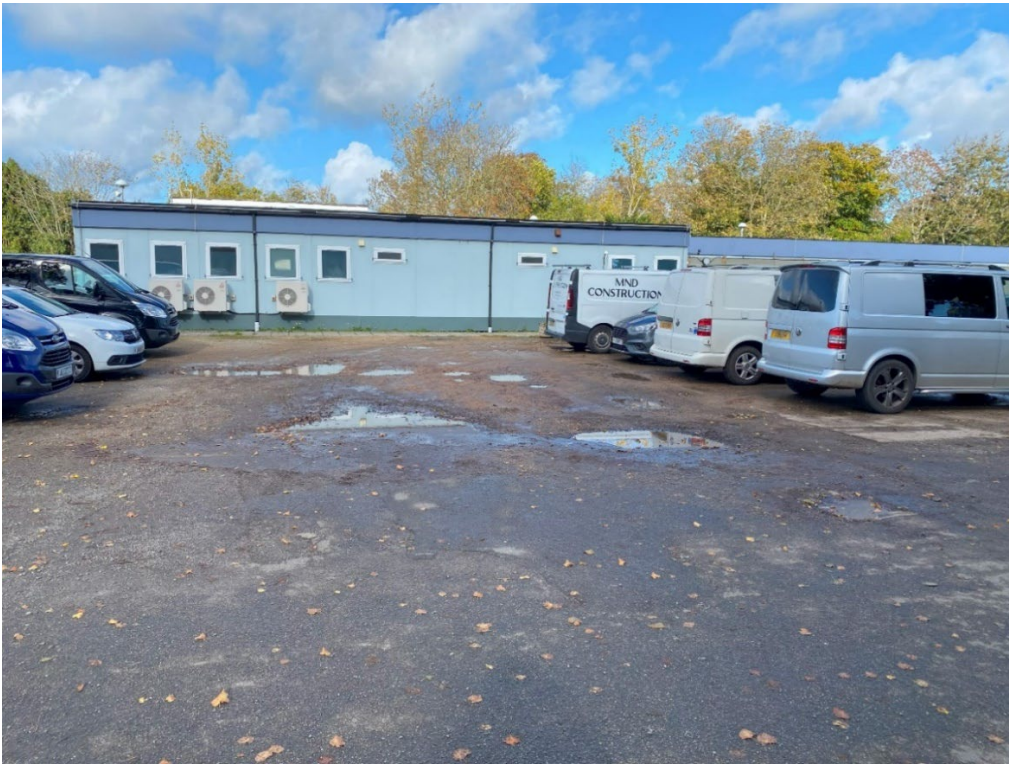
**D'Hautree Car Park** – surface has significantly deteriorated leaving a number of potholes presenting a hazard for pedestrians and vehicles

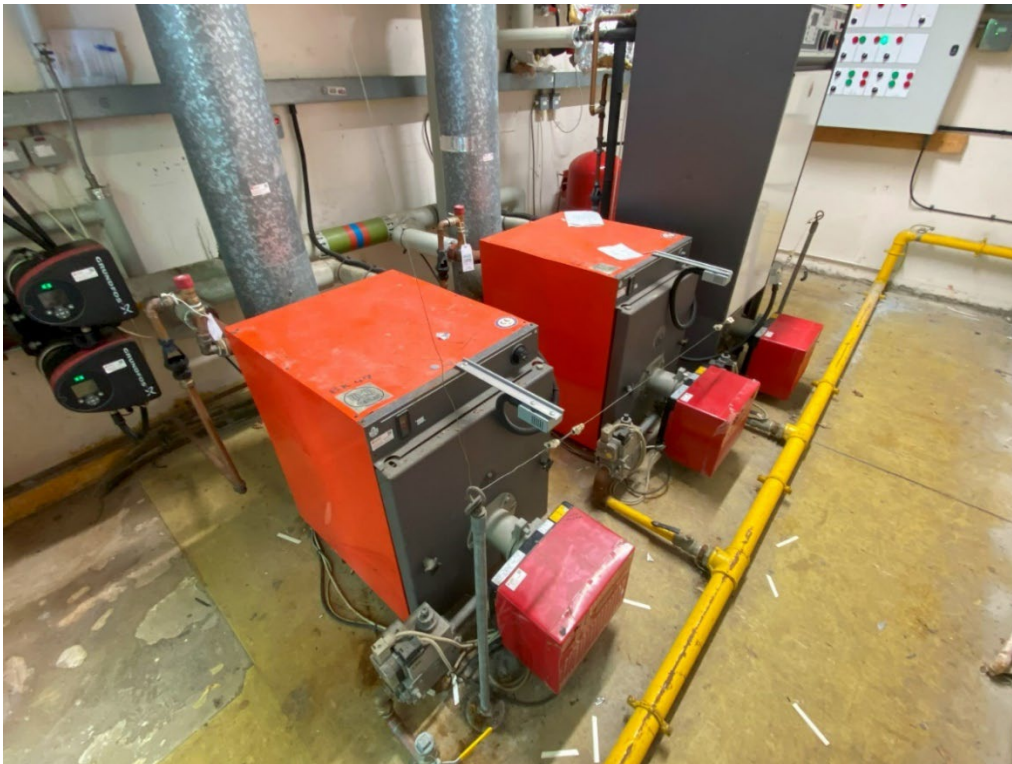
**School of Art** – Ground floor – two gas fired boilers and external burners require replacement being beyond their economic life

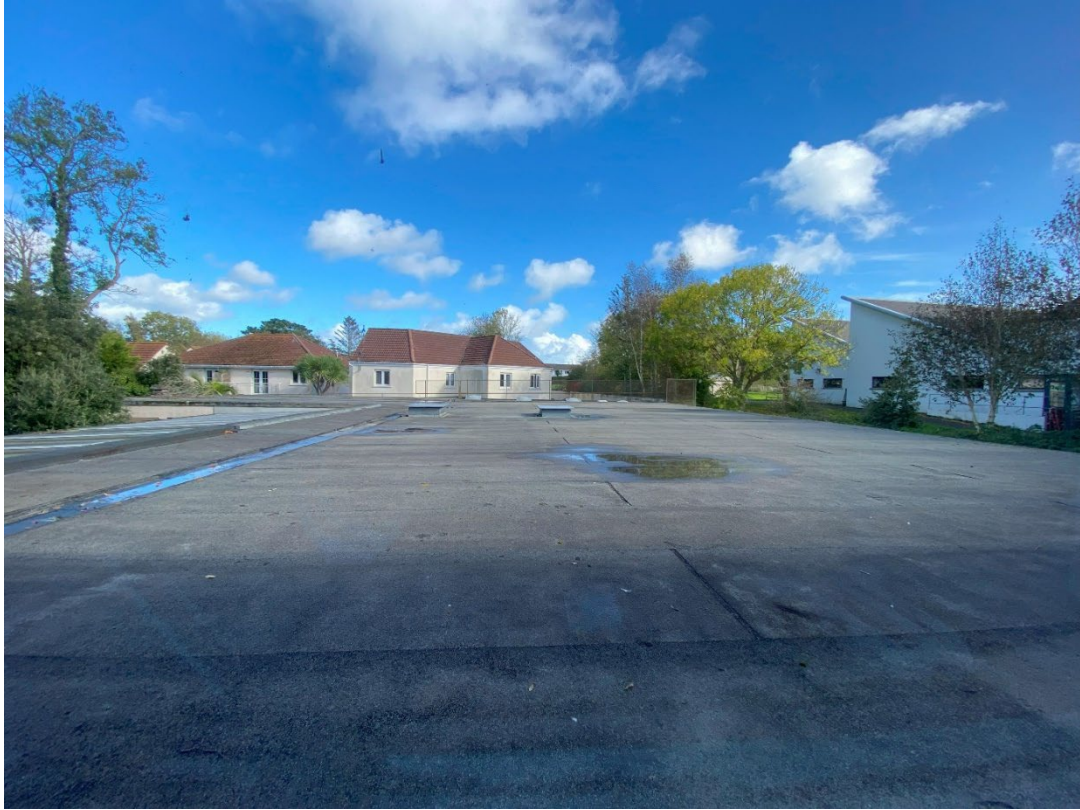
**School of Art** – mineral flat roof covering over first floor is aged with signs of wear and ponding

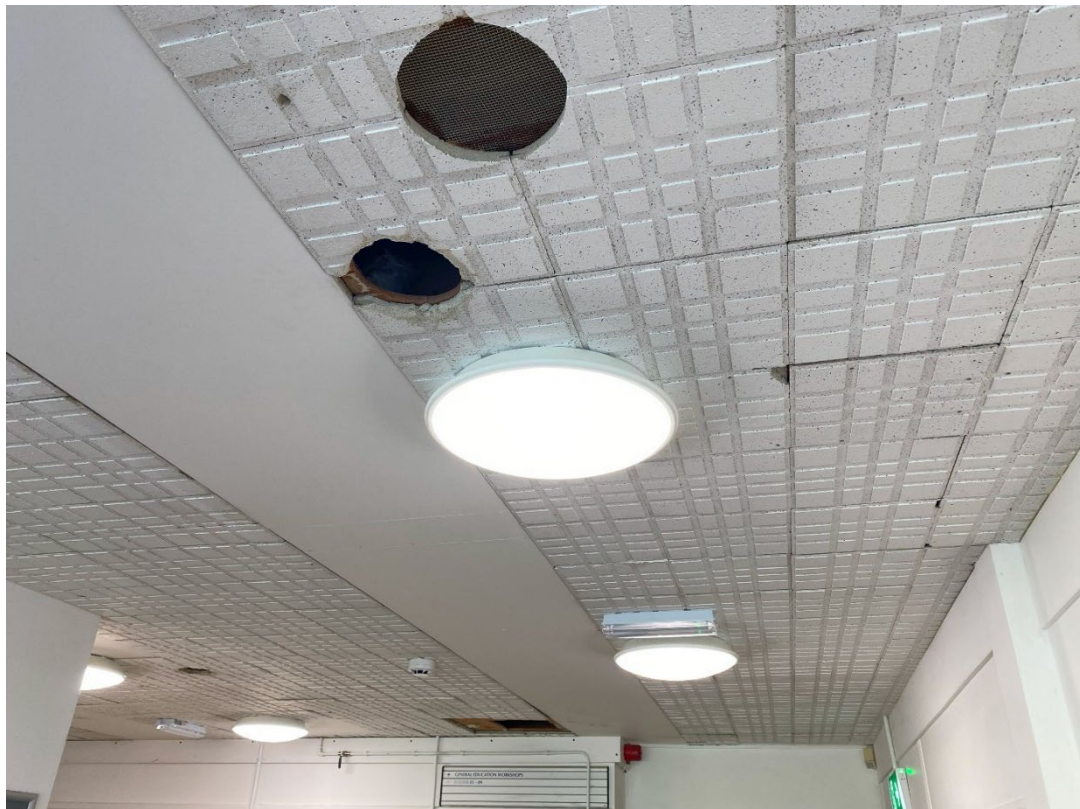
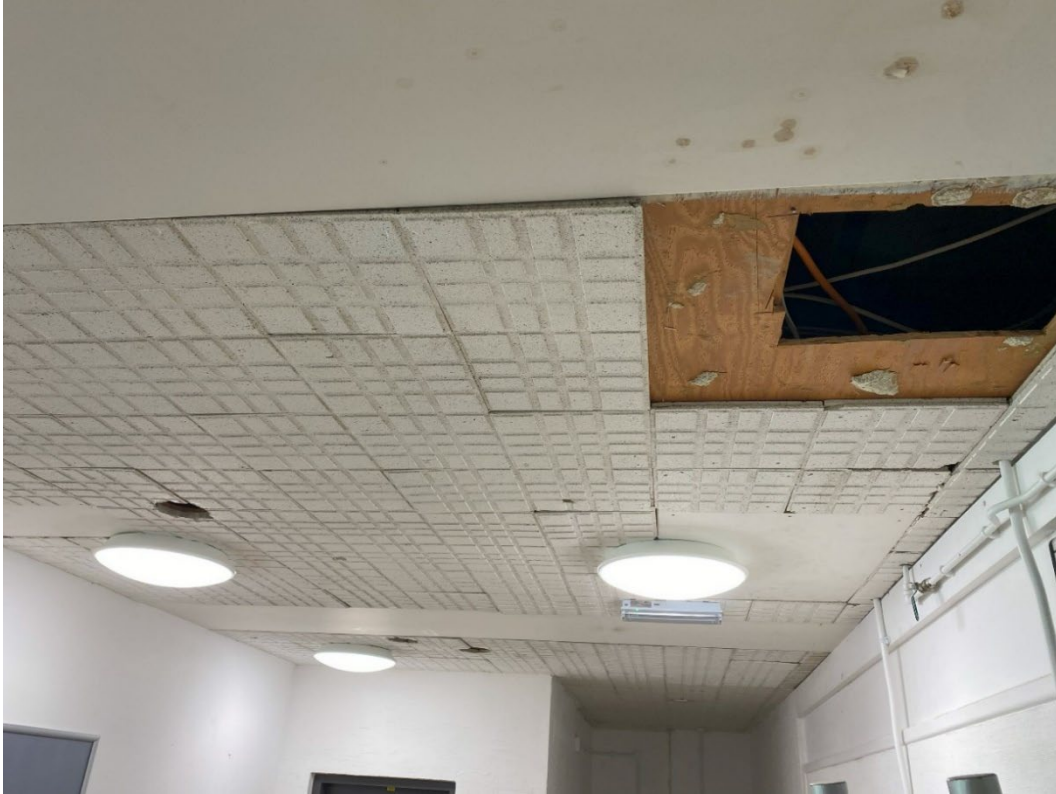
**Sport and Media** – condition of ceiling panels is very poor due to their age and recent water ingress.

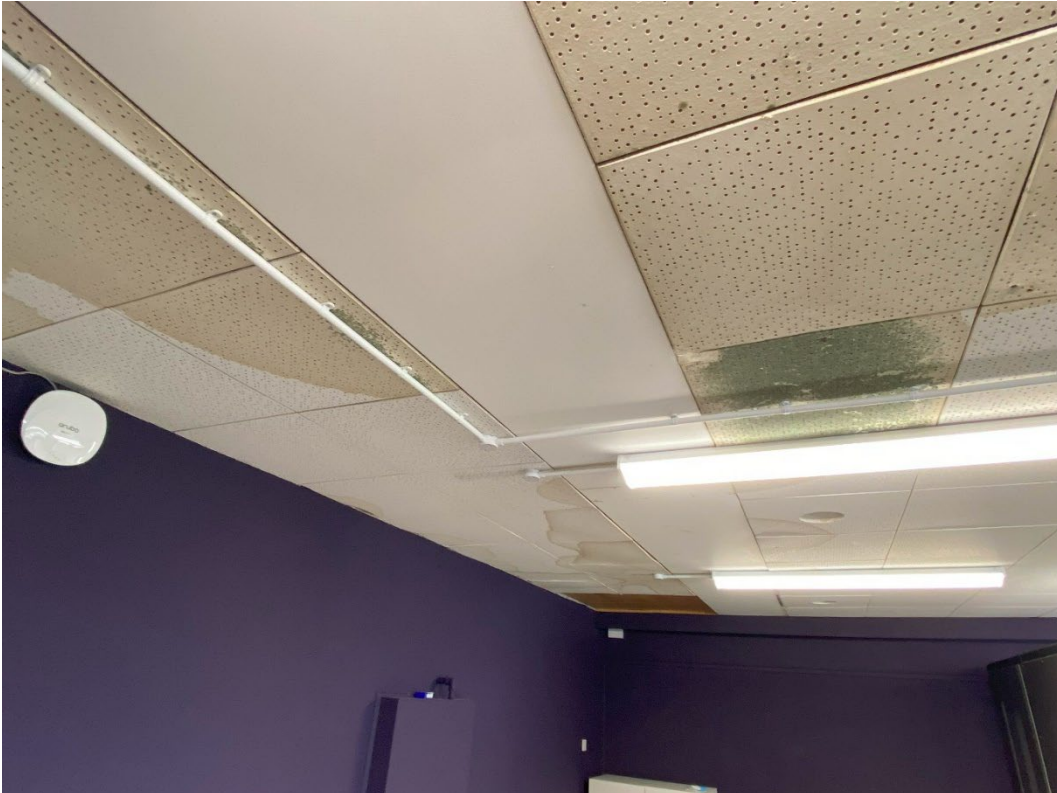
**Sport and Media** – Room 004 – mould and water staining from recent water ingress presents health and safety hazards

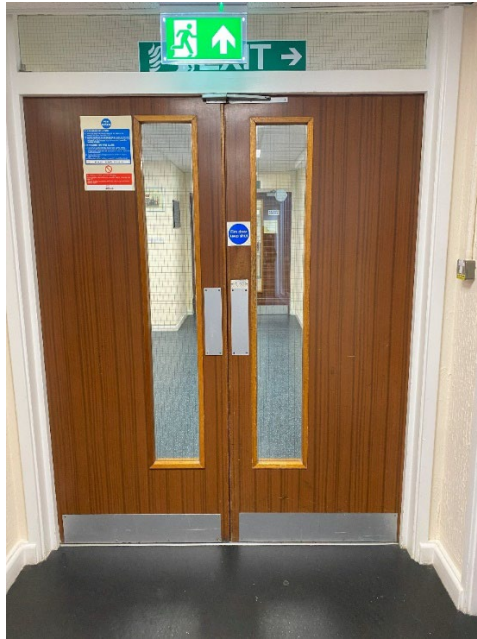
**Construction and Engineering** – Whole Block – internal timber doors subjected to ongoing wear and localised impact damage. Fire resistance does not meet current standards and require replacement.

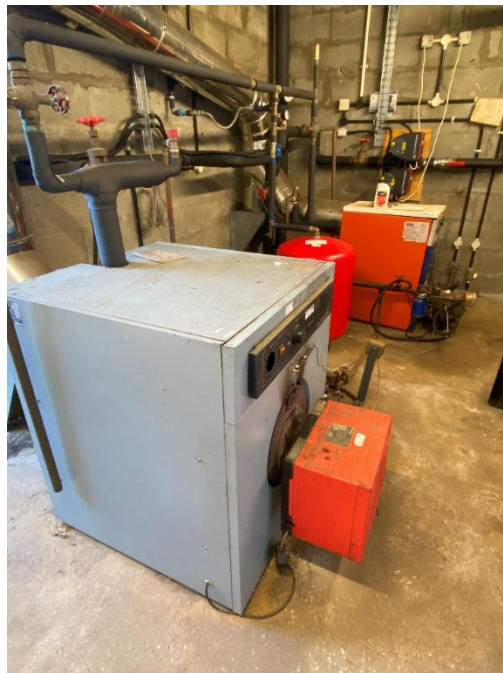
**Construction and Engineering** – Ground floor – two floor standing boilers with external burners are aged and require replacement.

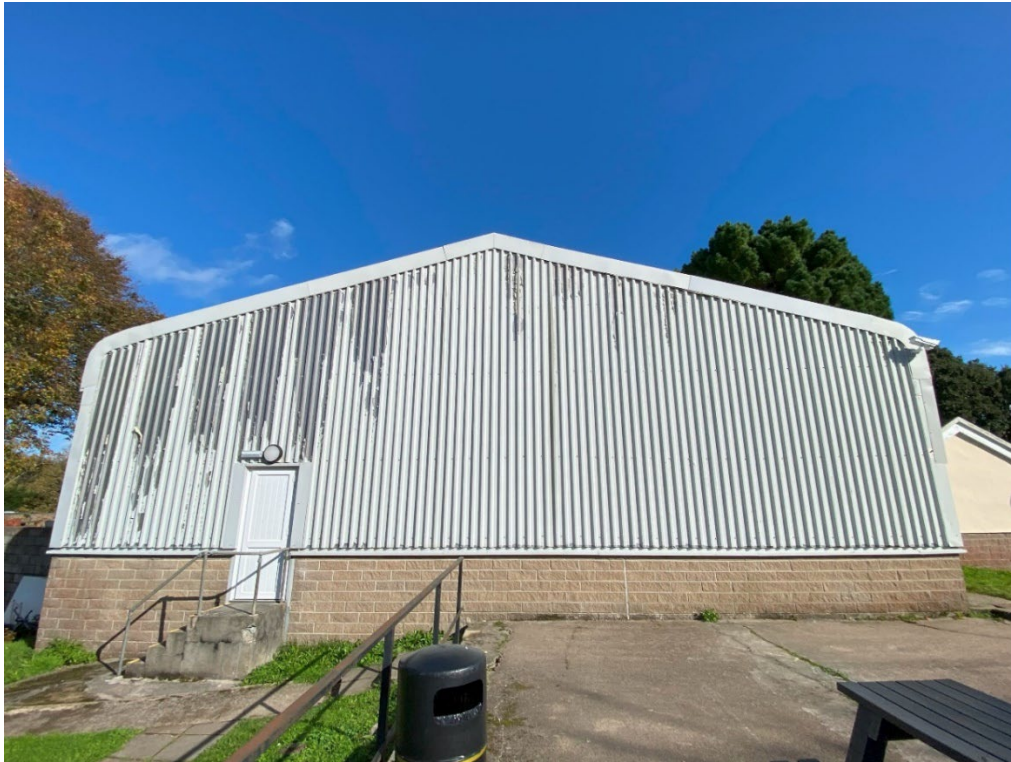
**Nash Building** – steel portal frame – significant corrosion to sections of the framework and supports. Worst affected areas seen to front elevation as a result of water ingress to window surround.

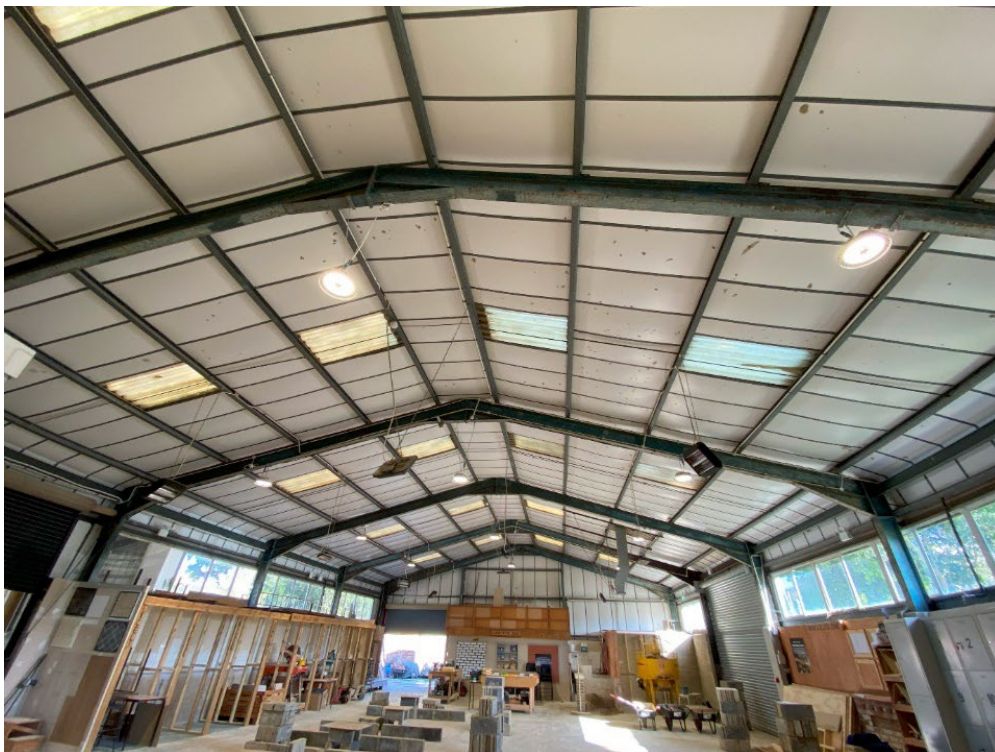
**Nash building** – insulated panels to the underside of the roof: staining and bowing noted and unlikely to meet modern insulation standards

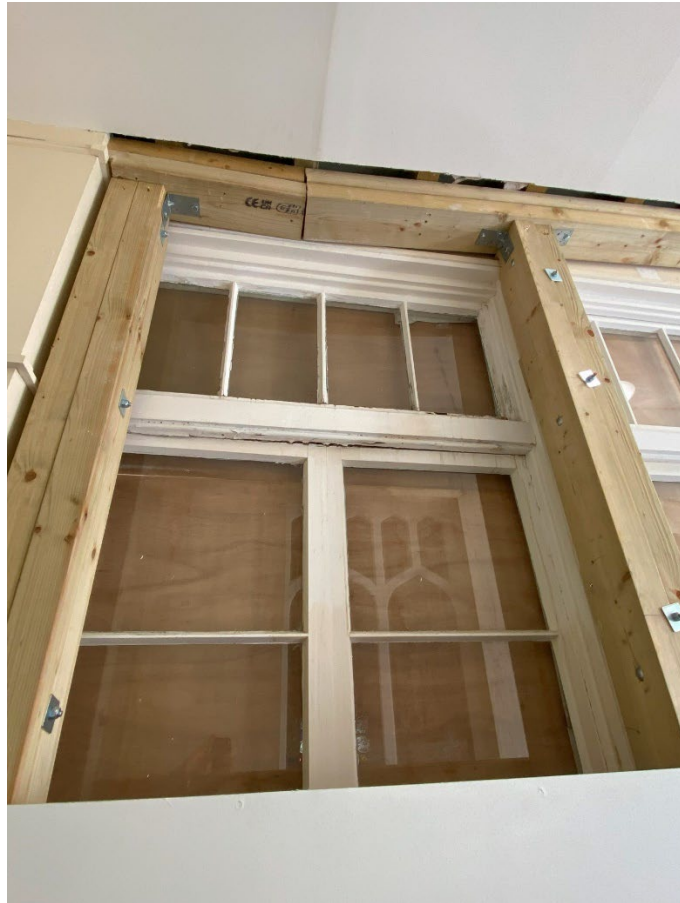
**Turner Building** – timber framed single glazed windows to the link corridor (either side of the Main Hall): water damage noted to the frames and timber panelling below with the South elevation worse than the North.
